Manhole Inspection Summary

Manhole # S06GG2002MH

Location Address: **7200 PARK HEIGHTS AVE**

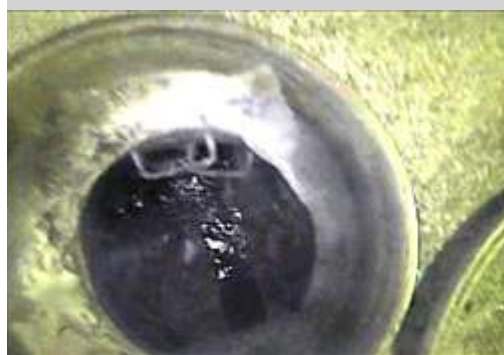
Top View

Bench debris.

Evidence of surcharge

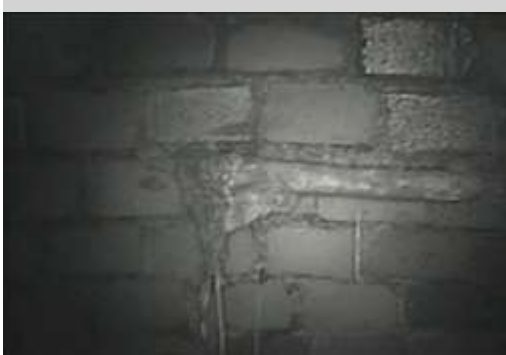
Defect

Frame leaks. Frame offset. Adjustment deterioration and infiltration.

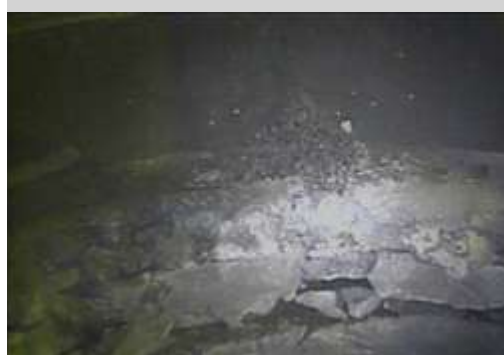
Defect

Adjustment and Corbel infiltration.

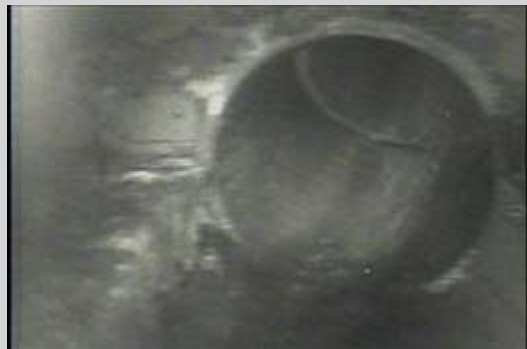
12 in. Circular Gravity Sewer

Infiltration: **Evidence**
